Beaver Township – Cunningham Road

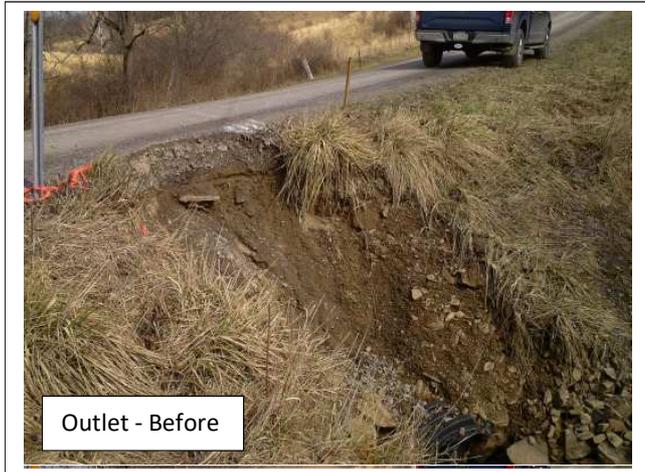
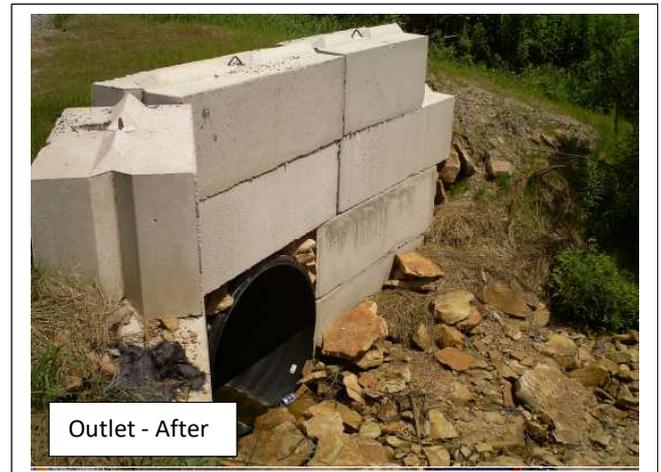
Problem: The existing 30" stream crossing pipe was too small. This crossing did not have headwalls or endwalls, which caused the road, road bank and berm to erode into stream. A lack of cross pipes on the hill leading to stream, caused runoff to erode the road berm and carry sediment directly to stream.

Solution: This project increased the size of the stream crossing pipe to 48". A cross pipe was added midway up the hill. Headwalls and endwalls were installed on all pipes. A stone filter was installed at the outlet of the cross pipe.
