## Clover Township – Shields Road

This was a Low Volume Road (LVR) Project.

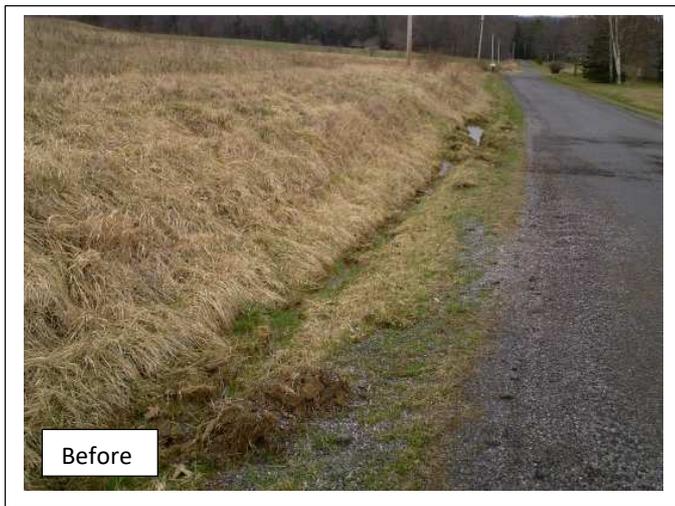
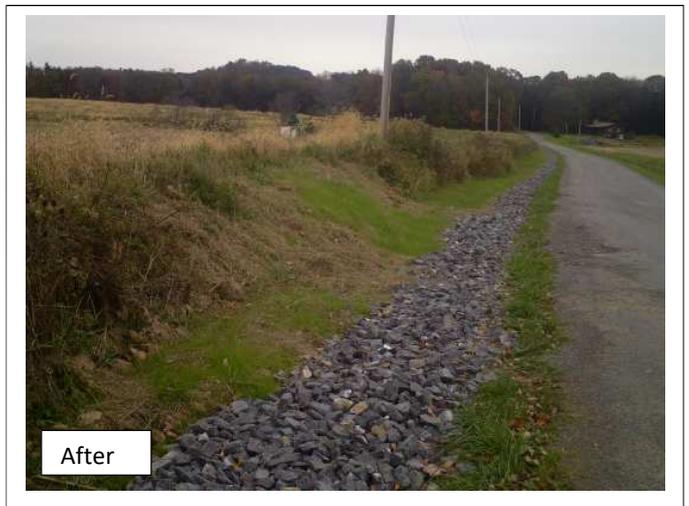
**Problem:** Several roadside springs were depositing water into the ditch causing it to become saturated. The existing crosspipe did not have a headwall or endwall. The banks surrounding the existing crosspipe were eroding. The road base was weakening from the water.

**Solution:** An underdrain was installed. The inlet of the existing crosspipe was stabilized with stone. A headwall and endwall were installed. The banks were stabilized with rip rap.

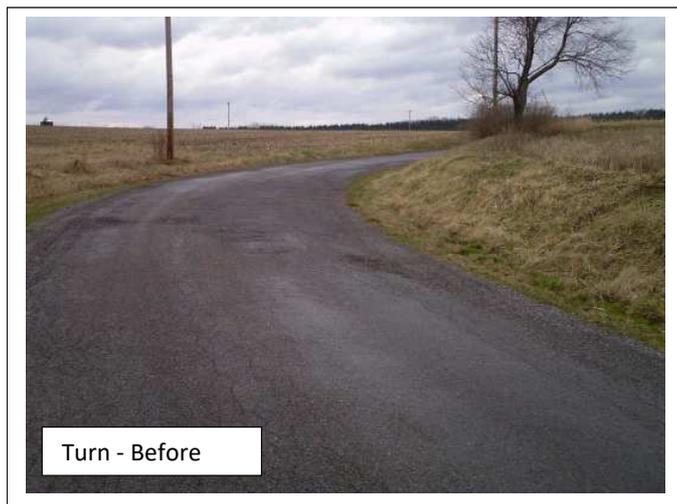
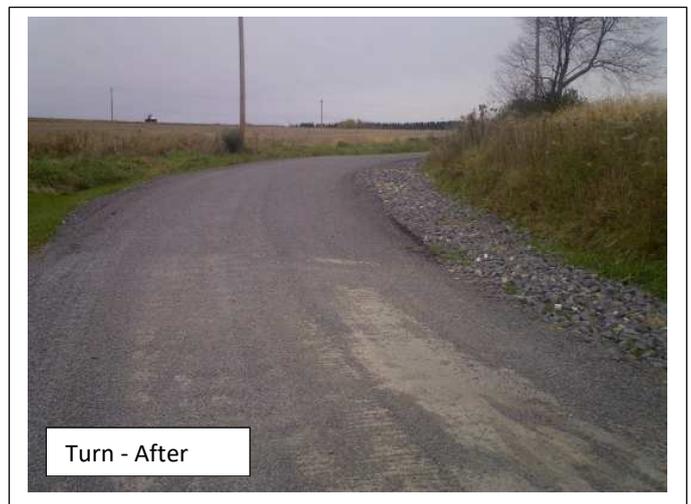
**Problem:** The ditch along the turn was saturated with water. The road base was wet and was sinking. The tar and chip was breaking up because of the soft road base.

**Solution:** An underdrain was installed to catch the water before going into the road base. The road base was stabilized and built up with fill.
