Clover Township – Toadtown Road

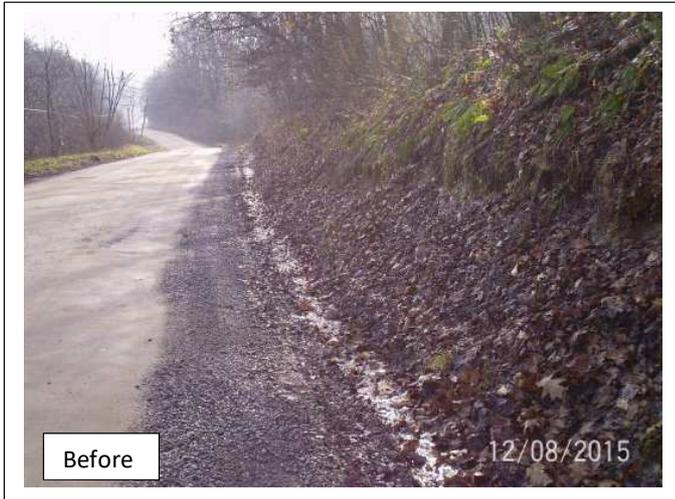
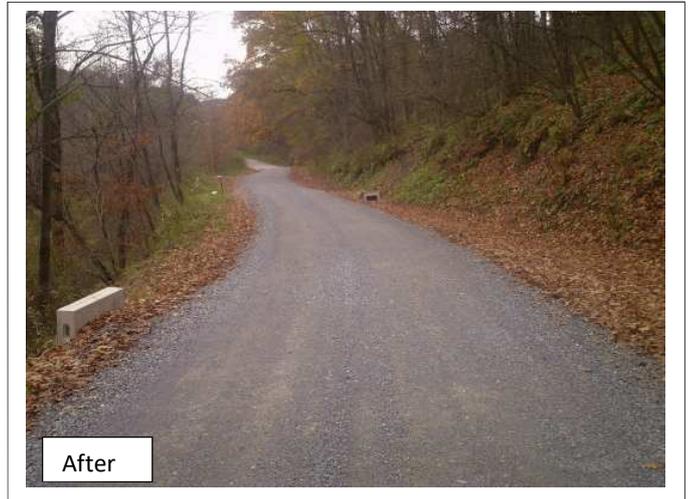
Problem: Existing ditches were saturated. There were a limited number of cross pipes, the road was entrenched and acting as a ditch. Sediment and road material were running off into the stream.

Solution: Additional crosspipes were installed with headwalls and endwalls. Turnouts were installed. The road bank was graded to increase sheet flow. The road base was built up and the road was crowned.
