Eldred Township – Greeley Road

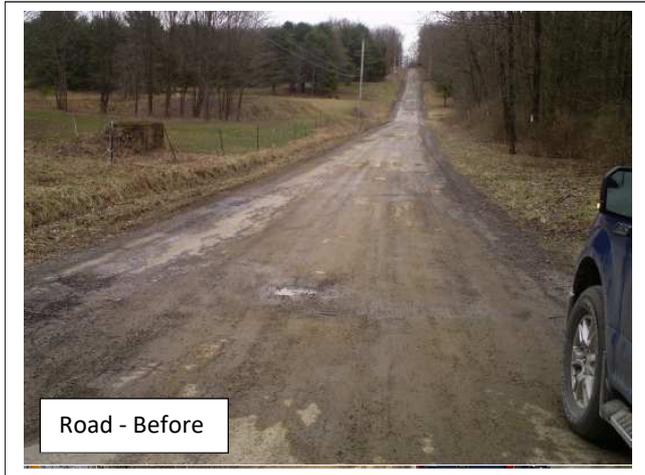
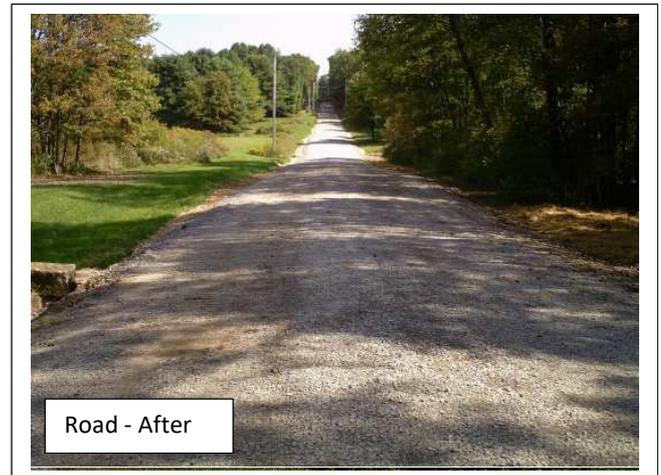
Problem: Groundwater and a lack of cross pipes was saturating the road base. The road was entrenched and acting as a ditch.

Solution: Three cross pipes were installed. Headwalls and endwalls were installed. 1440' of under drains were installed. The road base was built up 3' to encourage sheet flow off of the road surface.
