## Henderson Township – Branch Road

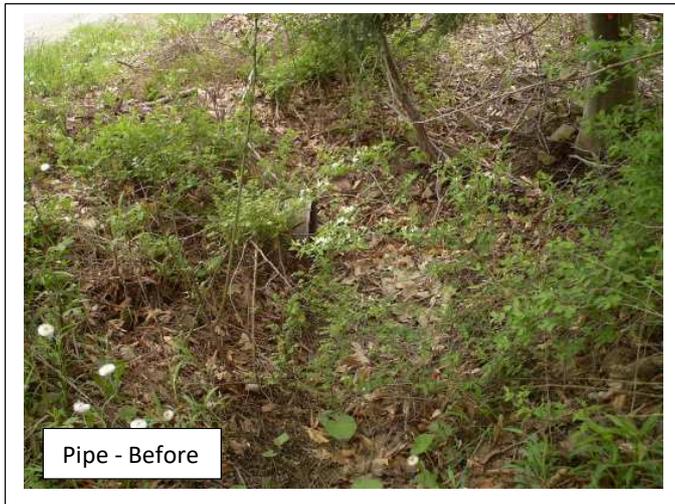
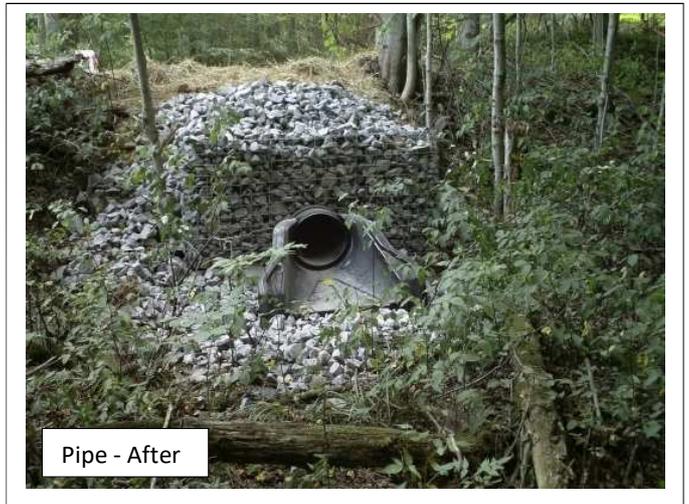
**Problem:** Water was coming down the ditch at a high velocity, causing erosion problems. There were not enough crosspipes in the road. The inside of the turn was too low, which did not let the water sheet flow off the road and directed sediment into the creek.
