Oliver Township – Mauk Hill Road

This was a Low Volume Road (LVR) Project.

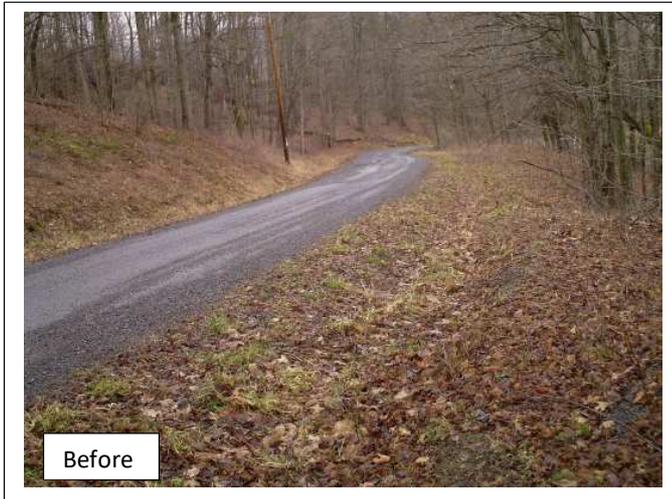
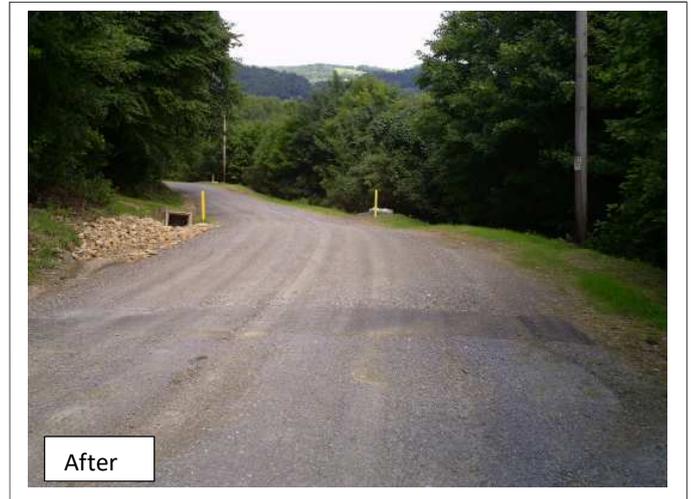
Problem: Excessive water was flowing in the ditches, causing erosion near the inlets and outlets of the existing crosspipes. The road base was soft from the excessive water and was causing the tar and chip to break up.

Solution: Additional crosspipes with headwalls and endwalls were installed. The bank was graded to encourage sheet flow. French mattresses and new turn outs were installed.
