Ringgold Township – Worthville Road

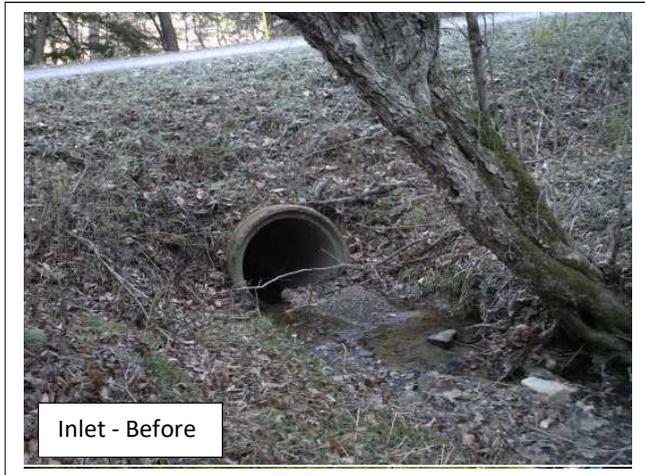
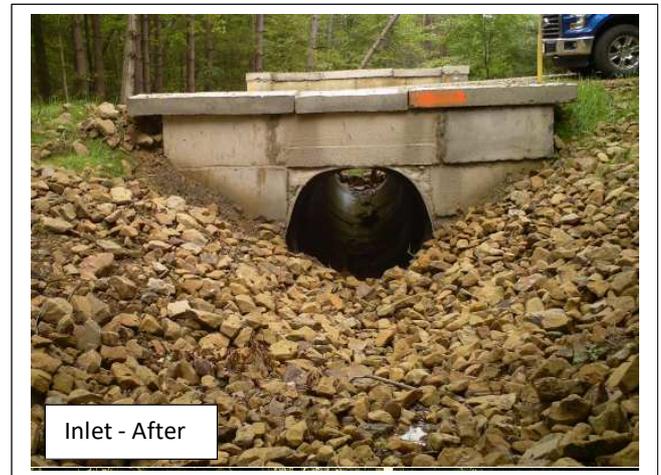
Problem: The existing stream crossing was undersized, causing a large amount of sediment deposition at the inlet. A section of the existing cement pipe had separated at the outlet, causing severe erosion to the stream channel and its banks. This erosion was also undermining the road, causing stability issues.

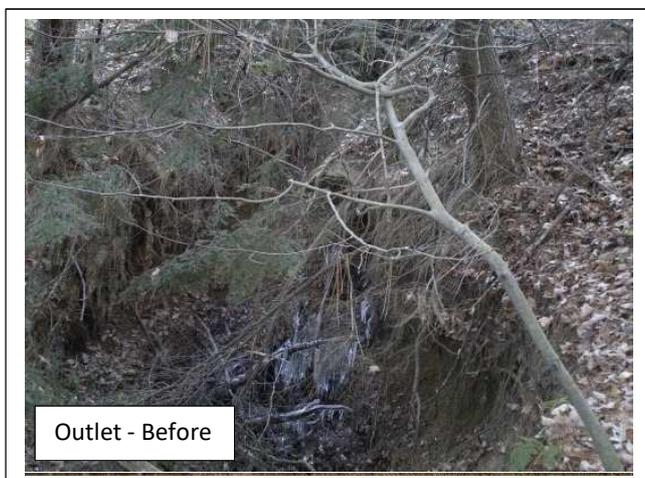
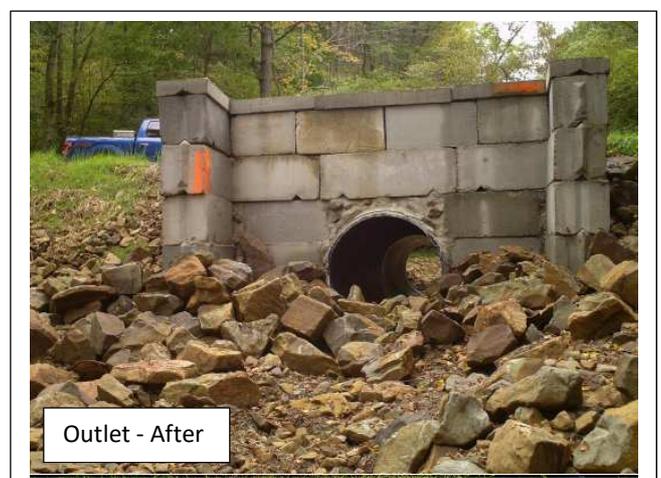
Solution: A larger pipe was installed to properly cross the stream. A larger headwall and endwall were installed to protect the banks. The eroded stream bed was stabilized with large, clean stone.
