McCalmont Township – Team Road

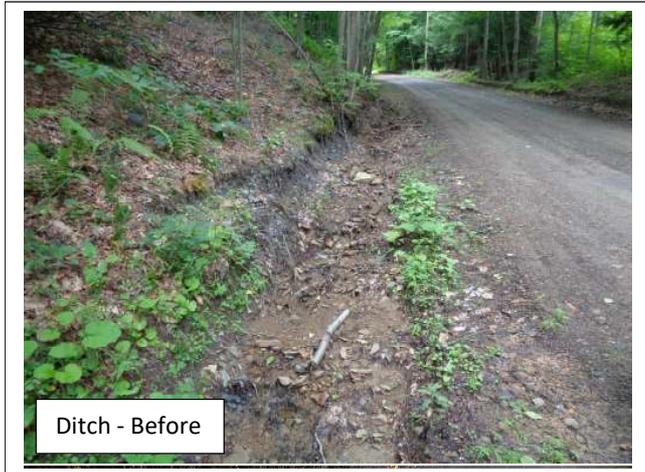
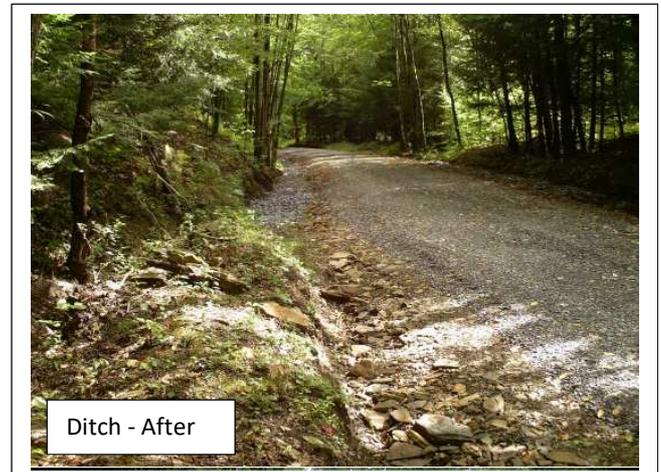
Problem: Groundwater was causing a soft spot in the road base. Excessive runoff flowing down the road ditch was causing severe erosion, resulting in a ravine at the outlet.

Solution: A French mattress was installed to help remove the groundwater from the road base. The road base was built up 12" and crowned to encourage sheet flow. #1 limestone was installed in the ditch to help dissipate and slow down any runoff. R5 & R6 stone was installed in the ravine to stabilize it.
