Oliver Township – Laurel Ridge Road

Low Volume Road (LVR) Project

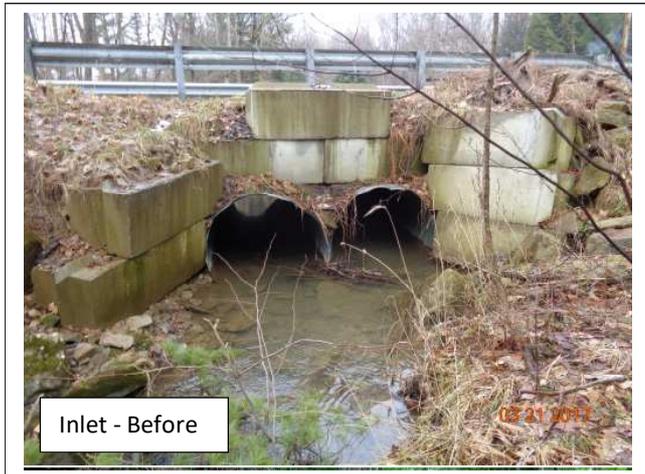
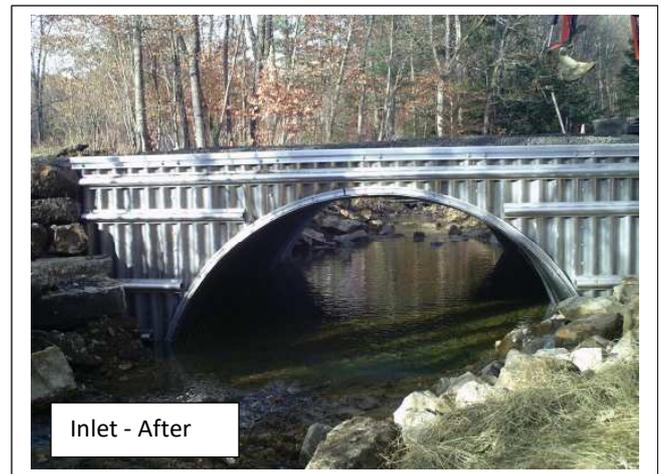
Problem: Existing double pipes were full of sediment, debris and were failing. Erosion was occurring around the headwall and endwall. Road ditches went directly to the stream, causing erosion.

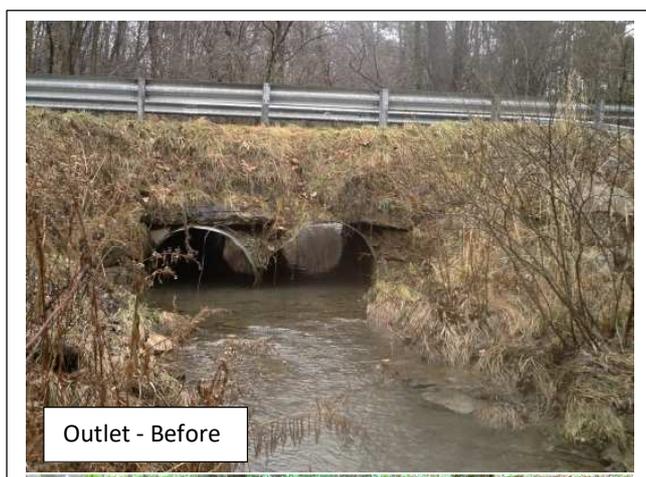
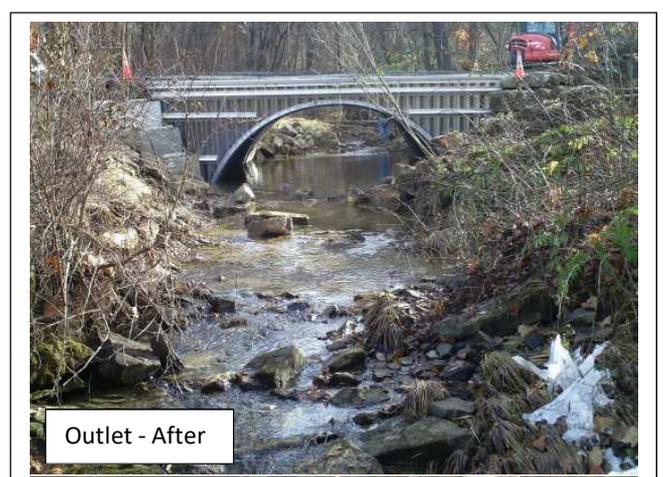
Solution: The double pipes were removed. A plated arch pipe was installed to meet DGLVR stream crossing specifications. A new headwall and endwall with wing walls were installed. A new cross pipe was installed with a stone filter at the outlet to help remove sediment prior to entering the stream.
