Polk Township – Bond Road

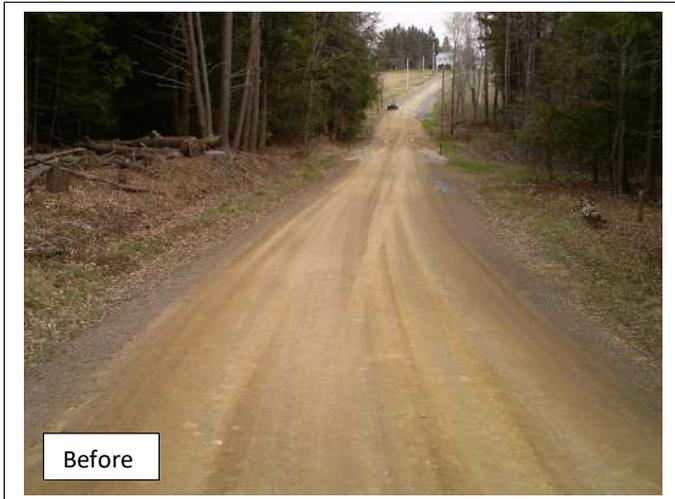
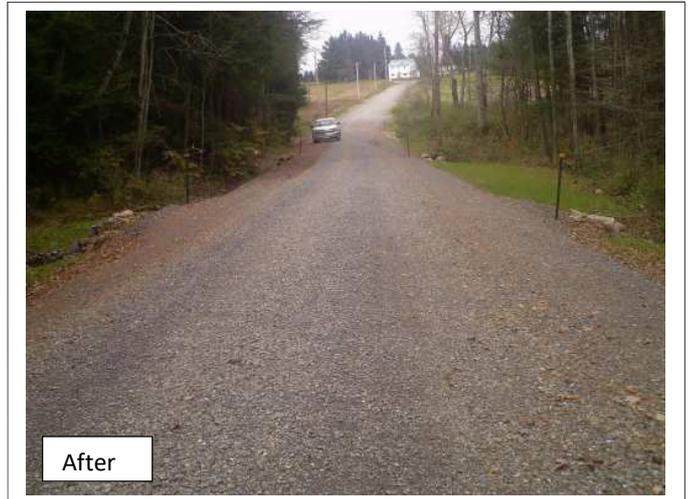
Problem: The road base was saturated and soft due to the existing streams and wetlands located along the road. The existing crosspipes were too small for the water flow, which caused erosion problems. The existing stream crossing was too small, which caused the road to flood during heavy rain events.

Solution: Underdrains, a French Mattress, and larger crosspipes were installed. The stream crossing was enlarged. The road base was built up. The road was properly shaped and graded to encourage sheet flow. The banks were graded and #1 stone was used to stabilize the outlets of the pipes.
