Ringgold Township – Reed Road

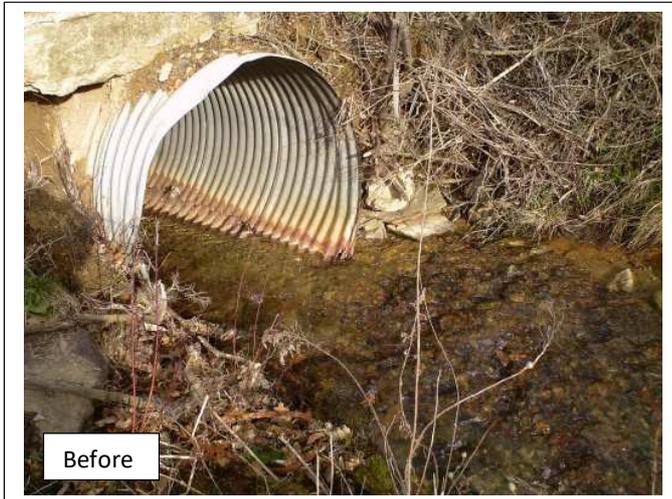
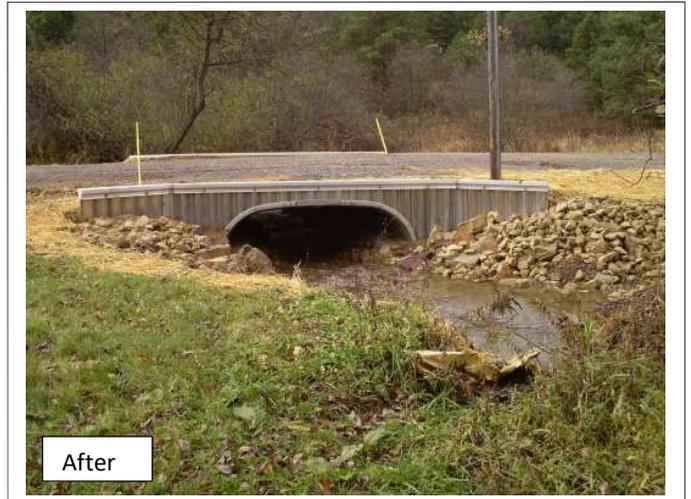
Problem: The existing stream crossing was too small for the water flow during heavy rain events. There was erosion on both the inlet and outlet of the pipe. The road material was washing into the stream.

Solution: A bottomless arch pipe was installed. The banks were stabilized with rip rap. The road was graded and reshaped.
