Summerville Borough – Broad Street

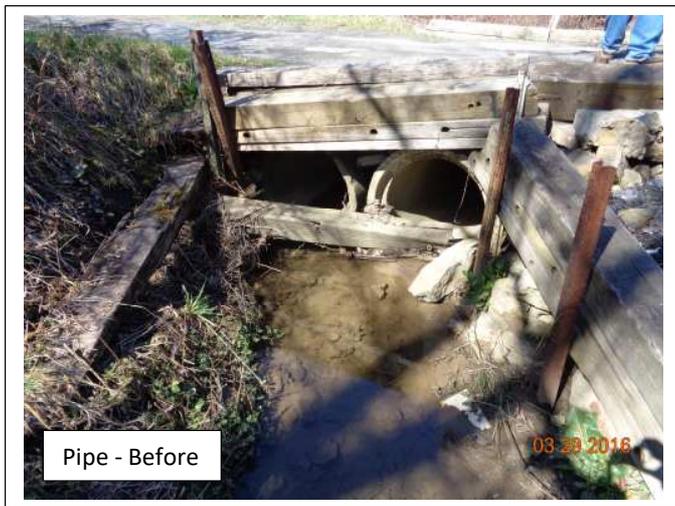
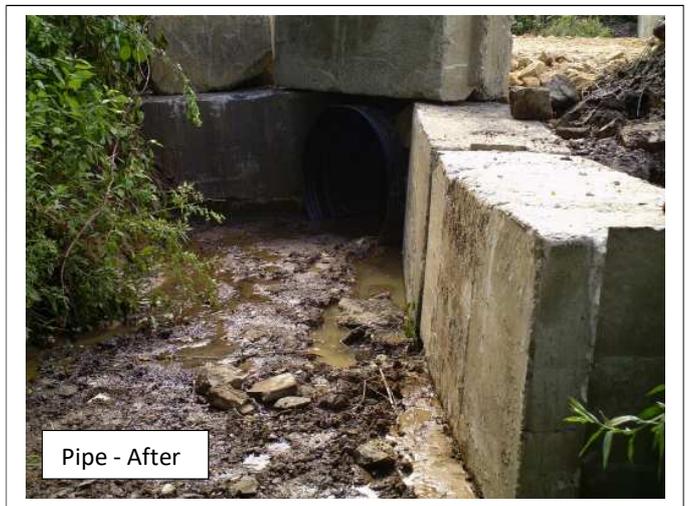
Problem: The existing double-pipe stream crossing was undersized and not functioning properly. Other existing crosspipes were also too small. There were wetland areas on both sides of road which caused the road base to be saturated and sink.

Solution: A larger, single pipe was installed at the stream crossing. Larger crosspipes were also installed throughout the project. The road base was built up after installing woven Geo Textile fabric to stabilize the road base. Underdrains were also used to help keep water from saturating the road base.
