McCalmont Township – Team Road

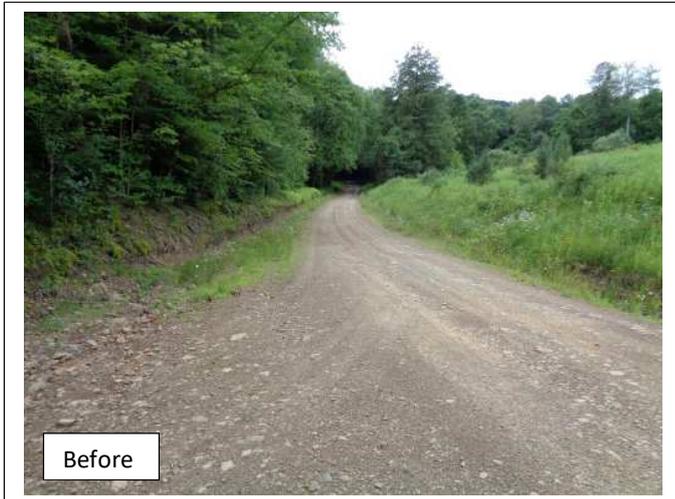
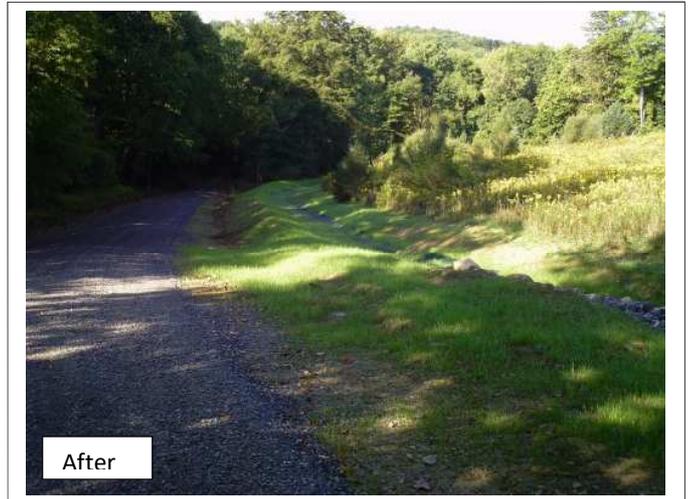
Problem: Water from two gas well access roads was causing high velocity runoff in the existing ditches. The road was entrenched and acting as a ditch. The water was all being directed to one area, causing severe erosion.

Solution: Numerous efforts were made to prevent runoff from concentrating on the roadway and its ditches, including: the installation of additional crosspipes, the construction of grade breaks on the gas well access roads, the development of a grassy water way, building up the road base with shale, cleaning out and stabilizing existing turnouts and installing new turnouts.
