Young Township – Setree Road

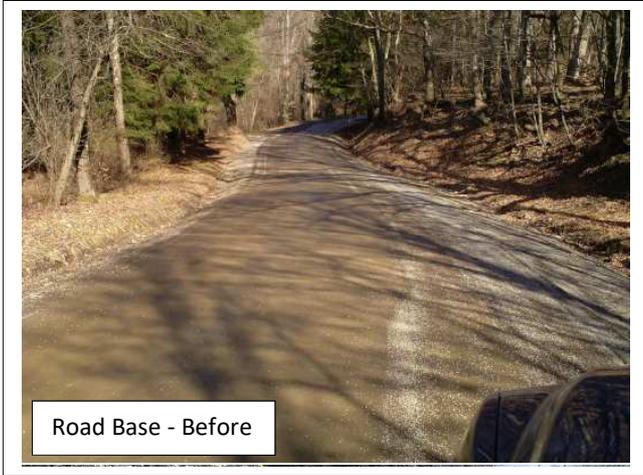
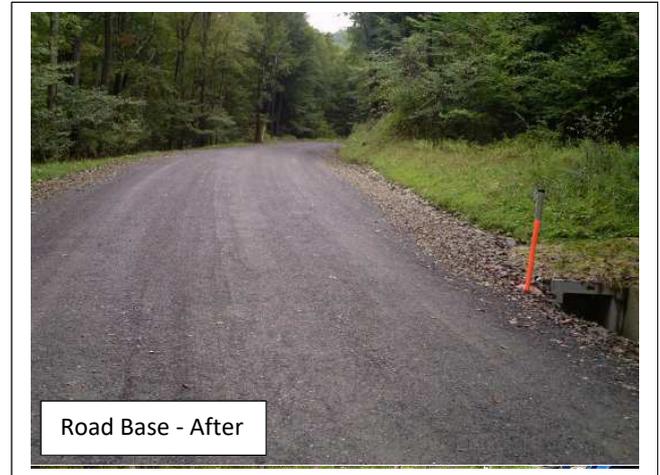
Problem: The number of existing cross pipes was inadequate, causing the road base to become saturated. Existing tree canopy cover was heavy, also contributing to the saturated road. Sediment was flowing from ditches directly into the stream at the bottom of hill. Road banks were eroding into the inlets of the existing cross pipes.

Solution: Additional cross pipes were installed. Inlet boxes were installed on their sides to help stabilize the road banks surrounding the new cross pipe inlets. Some trees were removed to provide daylight on the road. The road base was built up and turn outs were added to encourage runoff to leave the roadway.
