Young Township – Young Road

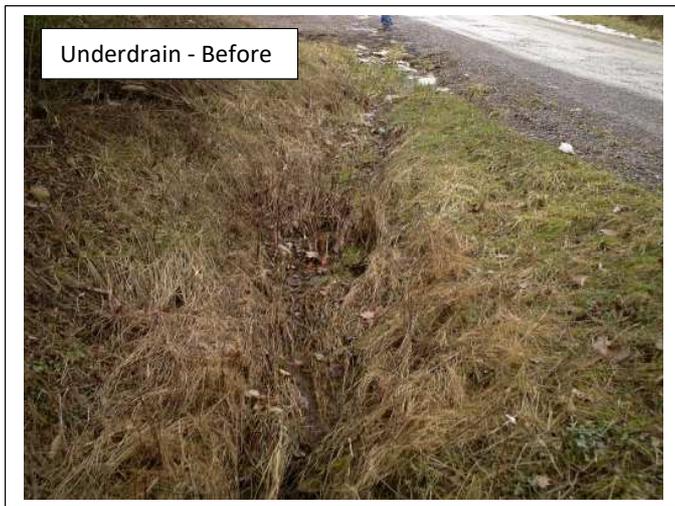
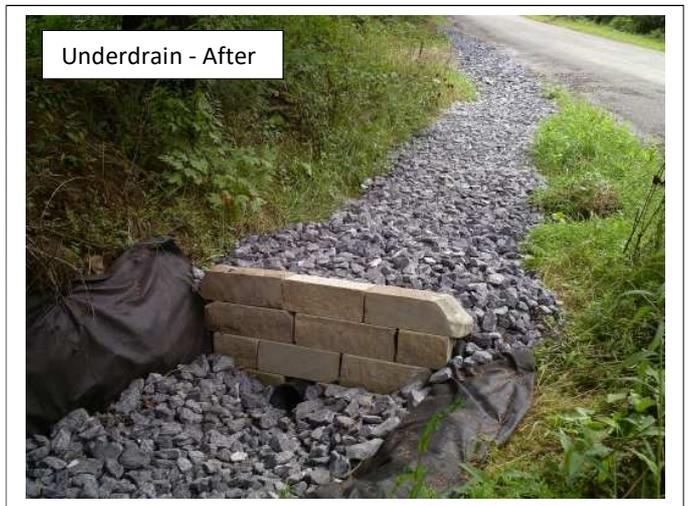
Problem: Existing road ditches were saturated. The outlet banks were eroded. Water was concentrating in one area, causing wet areas along the side of the road. Runoff from an existing gas well access road was overwhelming the Township road ditch, causing flooding.

Solution: New crosspipes were installed. The outlet banks were stabilized. An underdrain was installed. The banks were graded for sheet flow and the road surface was stabilized with DSA. The gas company installed a stone waterway on their road to divert the runoff from their road away from the Township road.
